COUNTRY Poland Approved For Release 2001/11/21 : CIA-RDP80-00810A000500TOPIC Liegnitz (Legnica) Airfield

EVALUATION [REDACTED] PLACE OBTAINED [REDACTED] 25X1ADATE OF CONTENT [REDACTED] 25X1CDATE OBTAINED [REDACTED] DATE PREPARED 9 February 1953

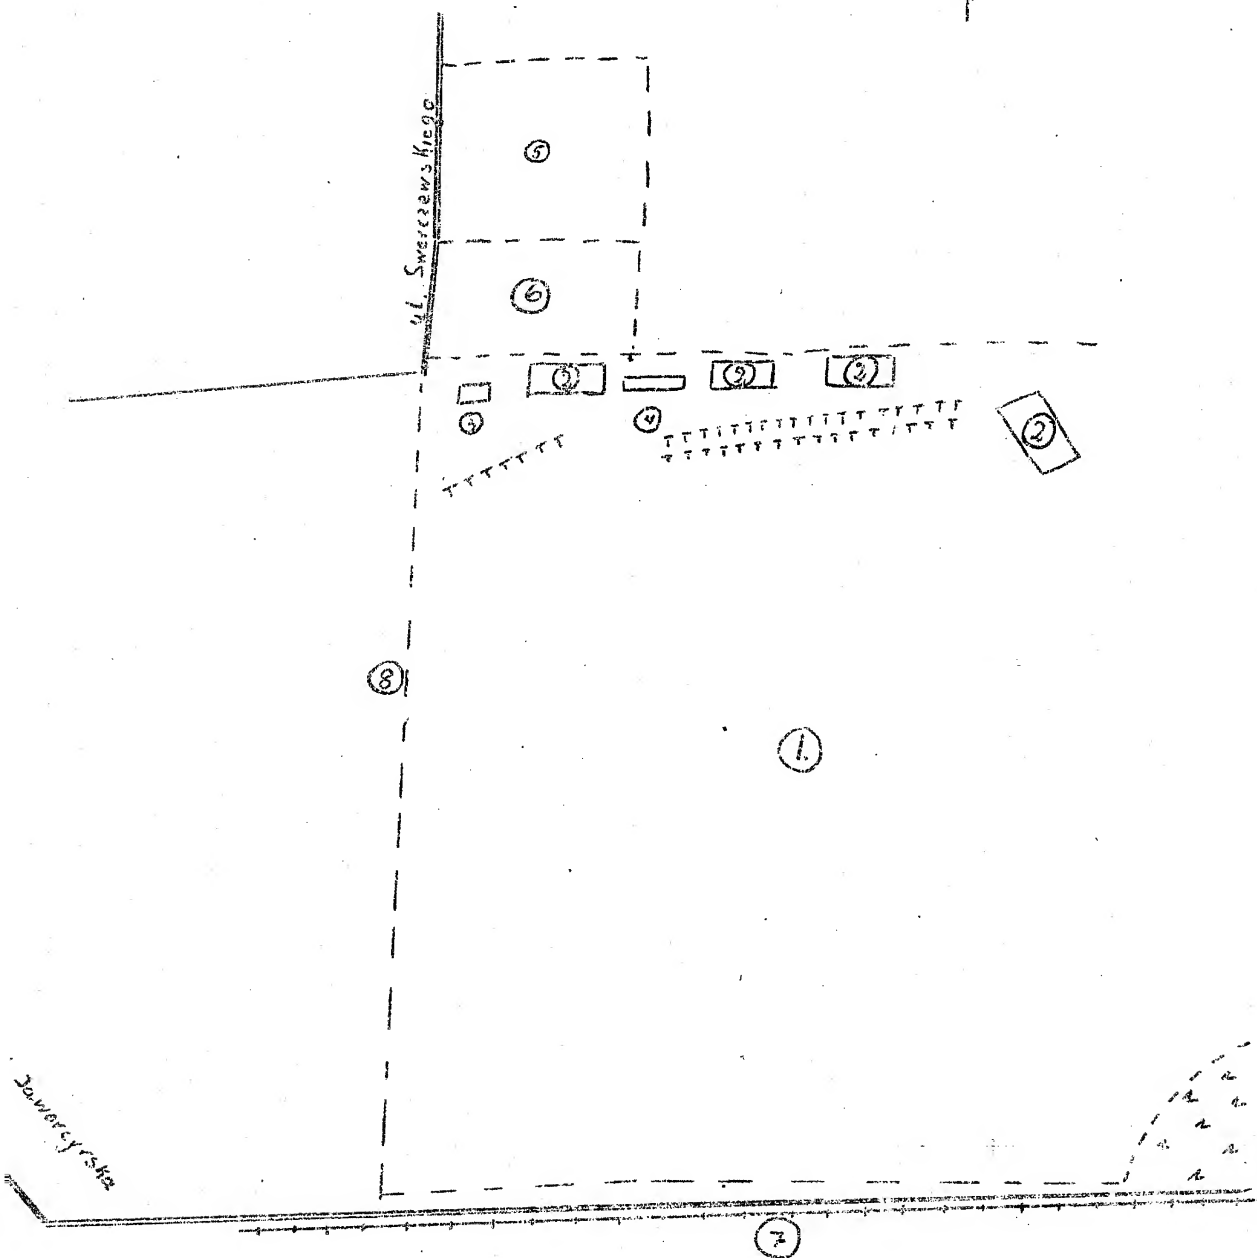
1. Liegnitz Airfield (O 52/B 82) is located on the southeastern outskirts of the town. From the north, ul. Swerczewskiego leads to the installation. The western and southern borders of the field were surrounded by a fence 1.5 meters high. A spur track extended from ul. Jaworczyrska in an eastern direction to the southern edge of the field. At 10:30 a.m. on 9 November 1952, source observed no construction work at the installation nor runways, taxiways and aircraft revetments. The field had a grass cover. ¹ The field was 1,300 meters from east to west and 1,000 meters from north to south. Installations seen on the northern boundary of the field from west to east included a guardhouse; a hangar; a three-story building, 80 x 20 meters, with yellow-grey plaster, a flat roof with a rectangular superstructure of trellis work, about 200 x 80 cm, equipped with antenna rods and meteorological instruments; three hangars, the easternmost of which was about 90 x 40 x 20 meters and had a vaulted roof. ² The other three hangars measured about 70 x 30 x 12 meters and had flat roofs. Six three-story buildings covering an area of about 60 x 18 meters and occupied by Soviet Air Force soldiers were observed north of the western hangar. North of these buildings was a barracks installation surrounded by a brick wall two meters high. The installation quartered a Polish Air Force unit and was guarded by a Polish Air Force soldier armed with a submachine gun. No air force soldiers were seen in the city. Many Soviet and Polish soldiers were seen by source in ul. Swerczewskiego. ³

1. Landing field
2. Hangars
3. Guardhouse
4. Flight control station
5. Barracks area, occupied by Polish Air Force unit
6. Barracks area, occupied by Polish and Soviet Air Force units
7. Railroad line
8. Fence
